RUBBER LINERS USED TO CREATE ROCK BOX IN SCREEN UNDERFLOW CHUTE

Regline PP Rubber Wear Plates and WB Rubber Wear bars were used to create a rock-box lining system to protect a screen underflow chute from high flow abrasion wear.

Improve lining system performance on screen underflow chute at gold & copper mine.

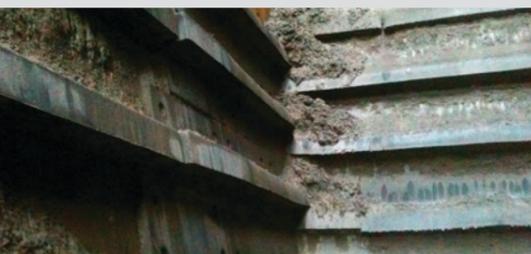
Reglin wear liners installed on screen underflow chute walls.

Reglin Rubber supplied Regline PP Rubber Wear Plates and WB Rubber Wear Bars which were installed into the Chute in a rock-box design as a wear liner solution against the combined abrasion and impact of the ore.

Rubber liners and bars were mechanically fastened onto the existing angled walls of the chute in a configuration which created a series of rock ledges. These ledges trapped ore against the chute wall resulting in less actual impact of ore against the liners as new ore flowing through the chute made impact against the trapped ore creating a rock on rock effect.

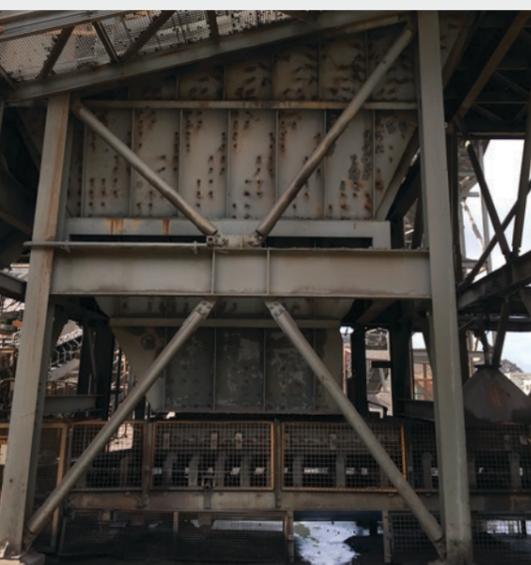
Critical screen underflow chute.

A new wear liner solution was required for a Screen underflow chute critical to the processing operation at the mine. The hardened steel liners being used currently were not lasting between shutdown cycles and were completely worn through regularly. This was damaging the structure of the chute and causing unscheduled shutdowns and loss of production. The Main Screen underflow chute was being subjected to extreme wear due to the high flow rates of ore being processed through the Screen directly impacting the chutes walls. The ore included highly abrasive fines up to medium sized rock.

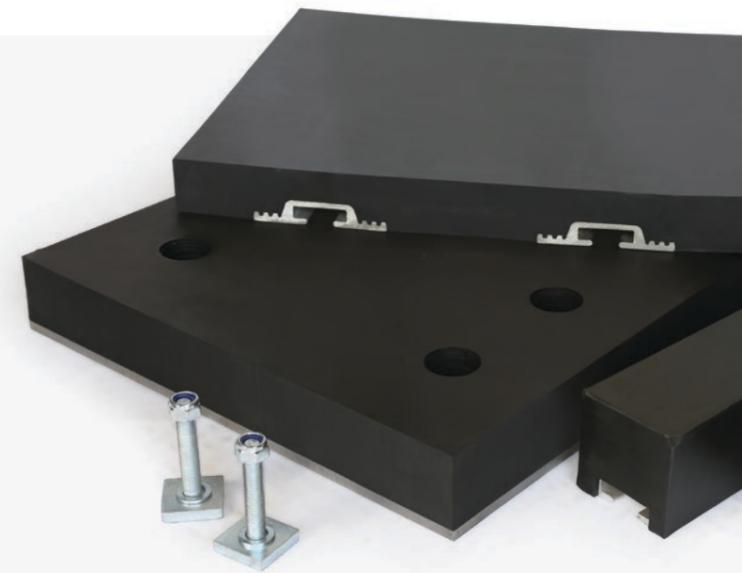
Ore falling into the chute impacts on ore trapped against chute wall

The combination of the premium wear resistant rubber lining absorbing the impact energy of the ore and the reduced abrasion on liners due to the rock-box design proved to give much better durability and have lasted significantly longer than previous steel liners designs.
